SERVICE BULLETIN No. BB/48, BB-S/9

- 1. WITH REFERENCE TO:** All hot air balloons Kubicek S/N 800 and higher except those equipped by single line deflation system.
- 2. REASON:** Discolouration of deflation system control lines has occurred which could impair their distinctiveness.

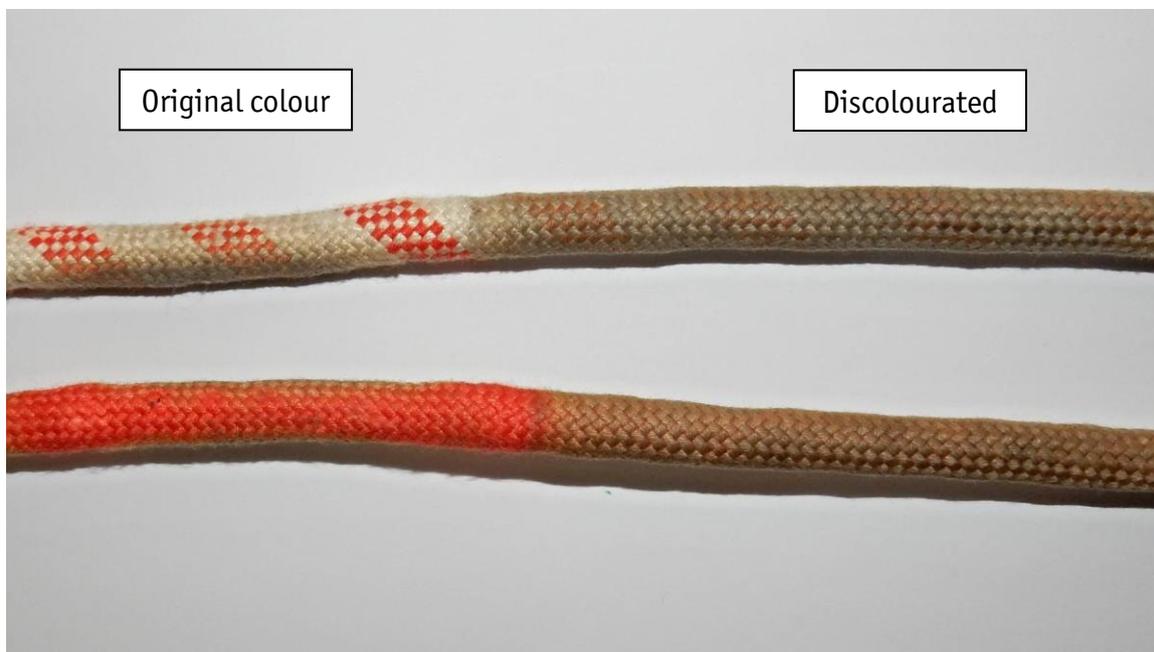
Example of discoloured lines

Here is an example of a red and white line and red line with significant discolouration than disables a simple and unmistakable distinction. Such lines need to be replaced.

- 3. REQUIRED ACTION:** Inspect all deflation control lines to check their colour remains clearly distinguishable. If discolouration occurs (see the photo on the next page), the affected control line(s) must be replaced with a new line.

- 8. PROCESS:** If necessary, replace the control lines according to the instructions provided in the Maintenance Manual (B.2202).
- 9. BULLETIN TAKES EFFECT:** **01 May 2016**
