## SERVICE INSTRUCTION no. 2020/01

### Repair method of damaged K40Y basket corner

**With reference to:** Kubicek Balloons K40 Y basket, S/N 140

**Action:** Repair of damaged corner

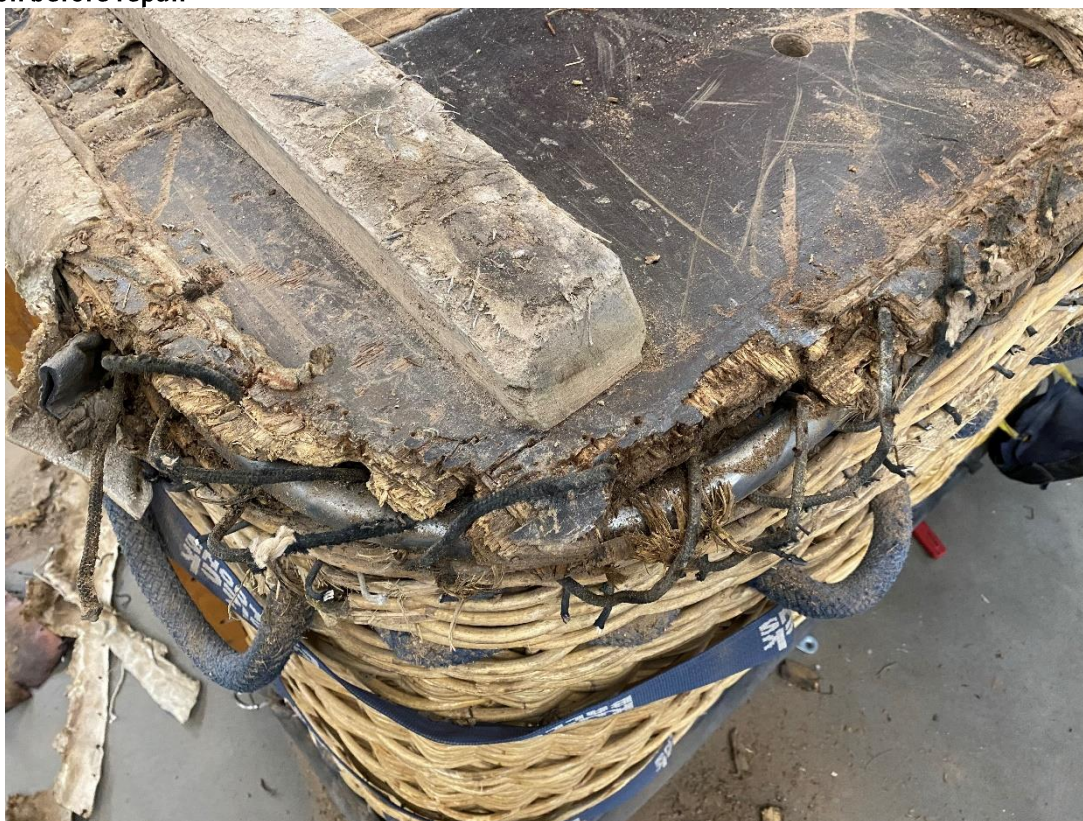
*Fig. 1: Condition of basket corner before floor disassembly*

From provided pictures was find out, that damage of basket corner is limited only to 8 pairs of wickers (stakes). 6 pairs are missing lower part (around lower frame) completely. 2 wickers (stakes) pairs have major damage of lower part, which should be repaired as well.

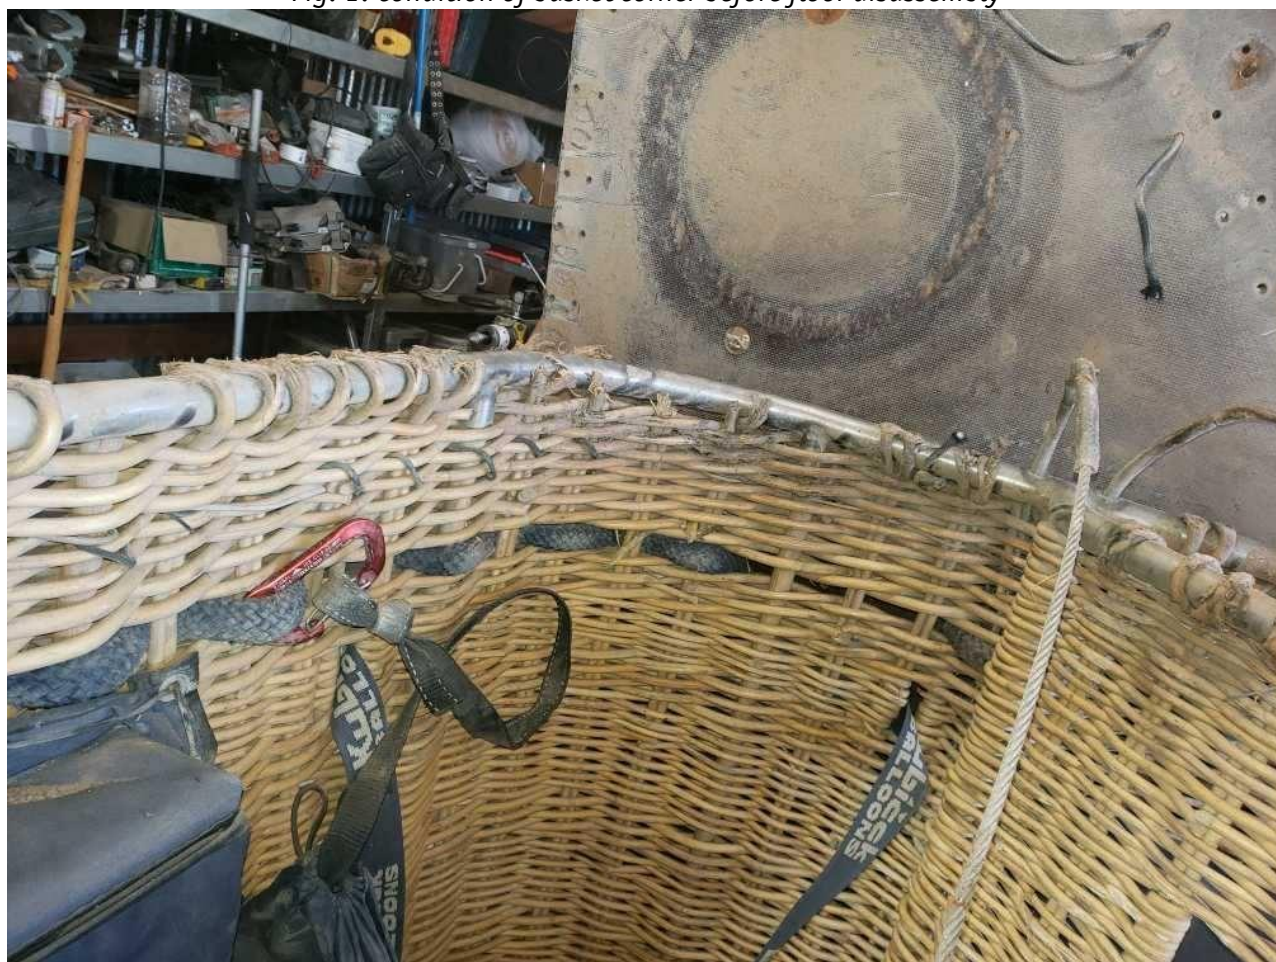
*Fig. 2: Condition of basket corner after floor disassembly*

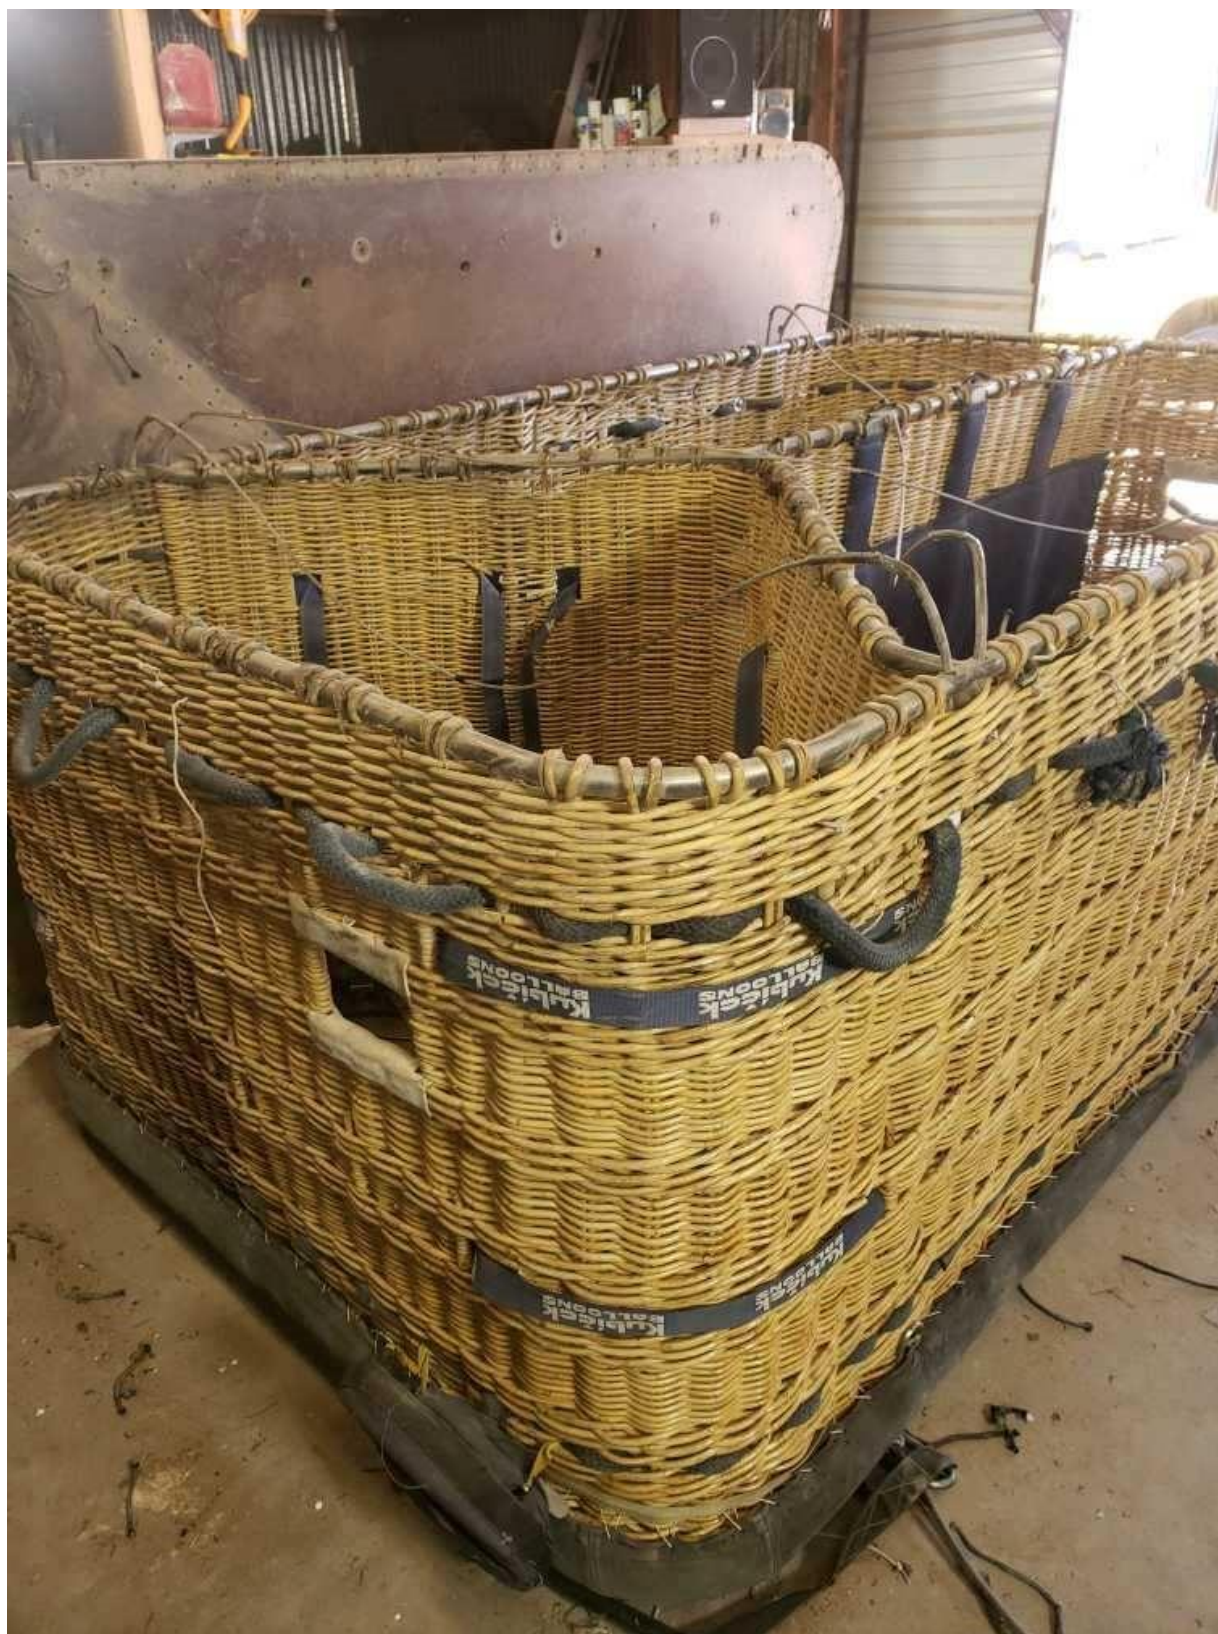
*Fig. 3: Condition of rest of basket after floor disassembly*

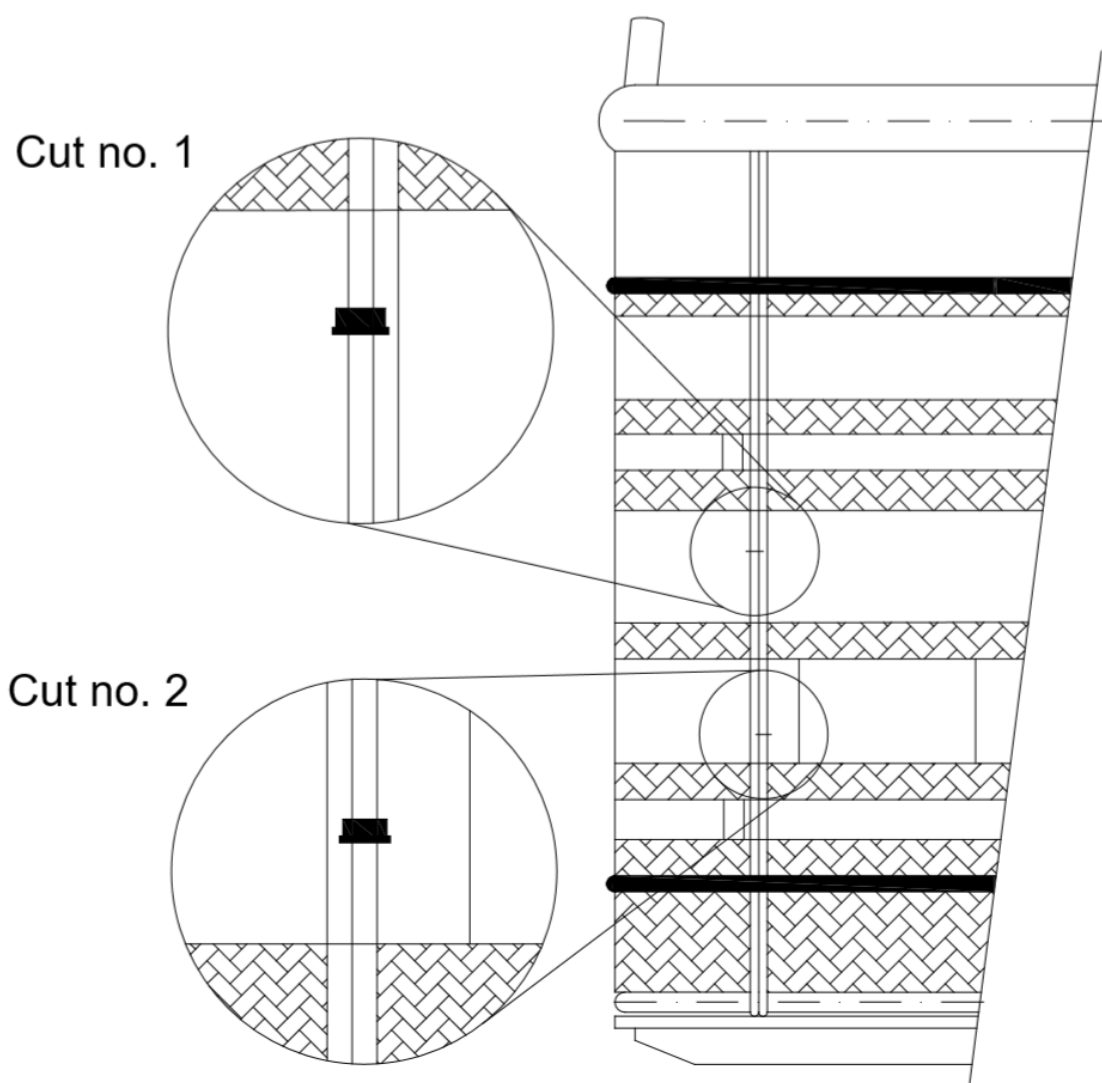
*Fig. 4: Where to cut wickers*

Repair contains cutting damaged wickers (each from pair in different height, please see *Fig. 4*). Damaged wicker parts must be extracted from basket corner and replaced by spare wicker pieces, placed back into woven wall, to replace of damaged ones. New wickers must be inserted fully into weave, to maintain as small gap between old and new piece, as possible.

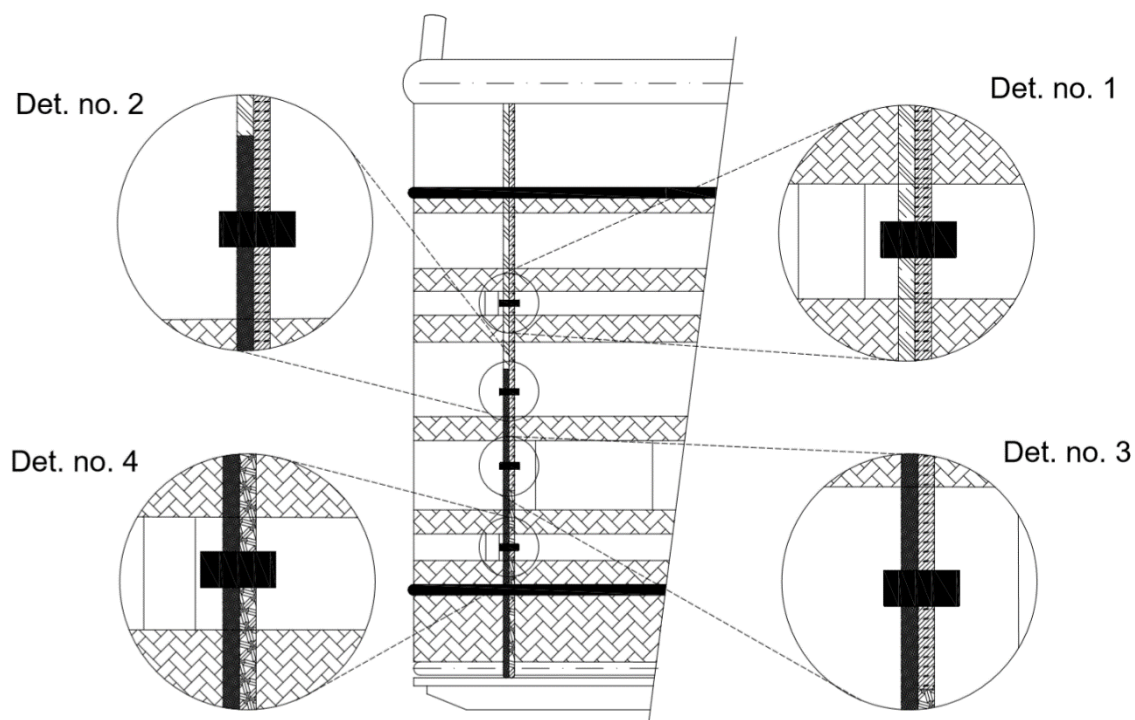
*Fig. 5: Details of connection between old and new wickers*

After replacing old damaged wickers, is necessary to tighten together new and old wickers at least at four points in different heights (please see *Fig. 5*). Tightening should be made in places, where isn't strength type of weaving. For tightening use Cable ties 200x4,6 mm (714.00).

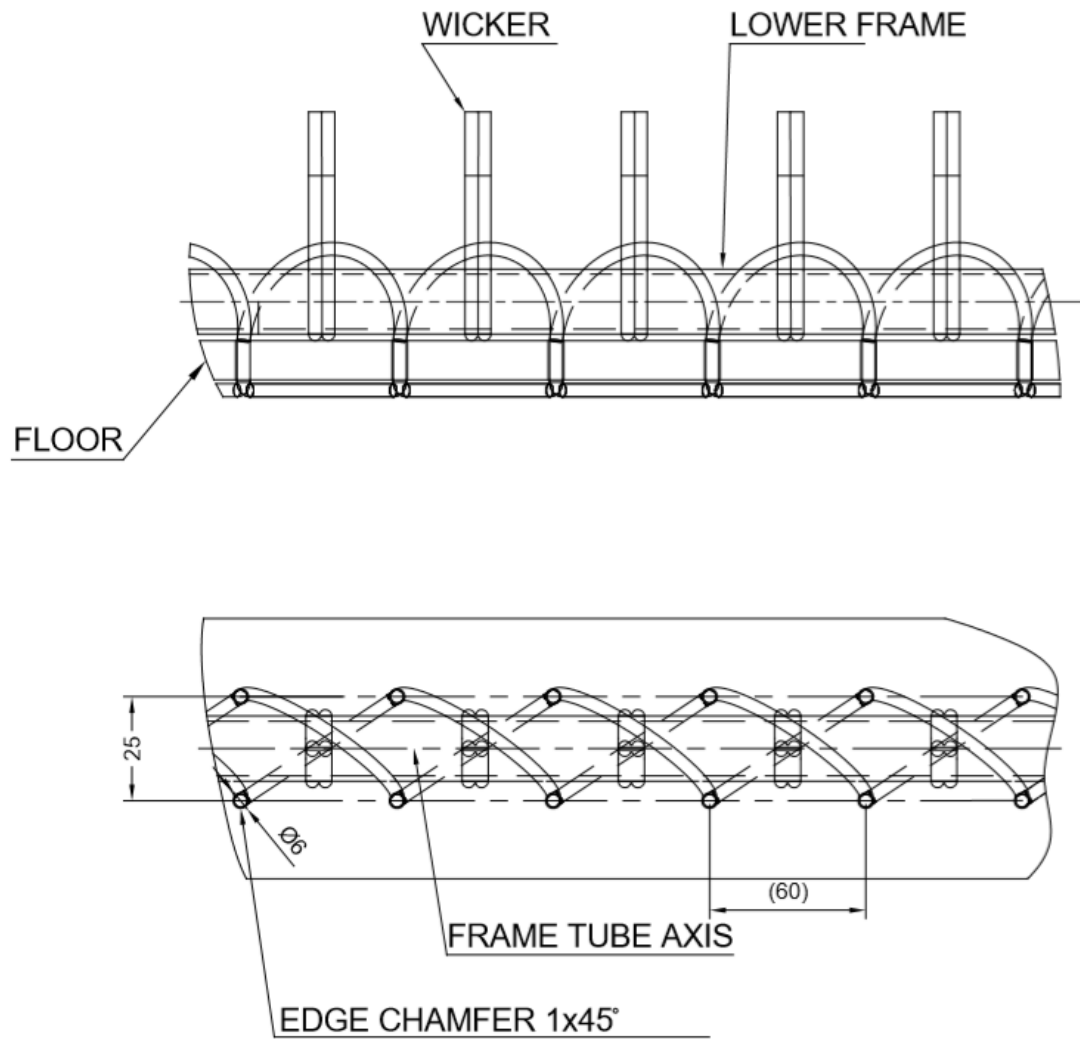
*Fig. 7: Floor assembly*

After manufacturing floor, it will be attached to lower frame as it is shown on Fig. 7 with black polyester line (diameter 5 mm).

USE BLACK POLYESTER LINE, dia. 5mm

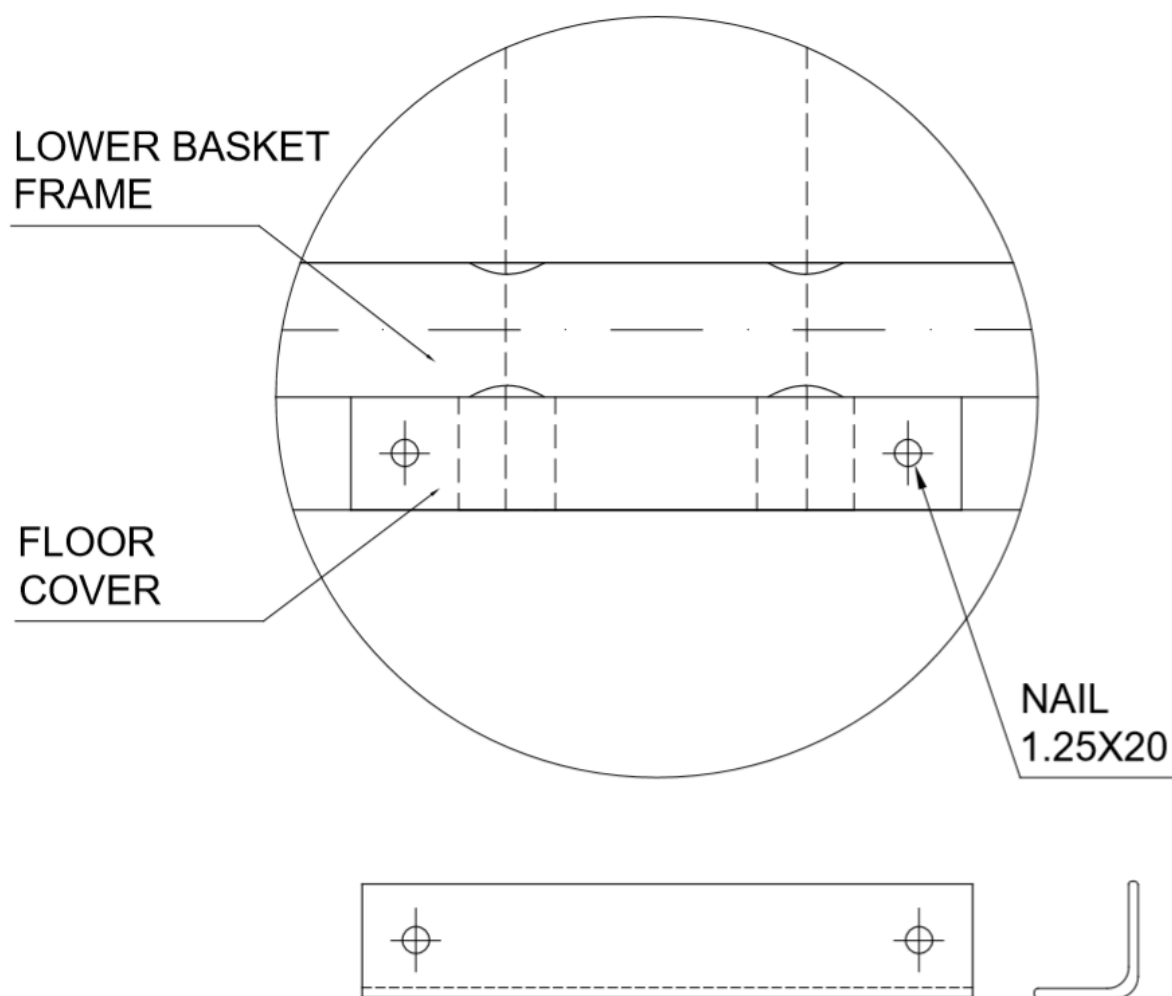
*Fig. 8: Floor cover assembly*

Steel cables covers (floor covers) are attached to floor by nails as shown on Fig. 8.

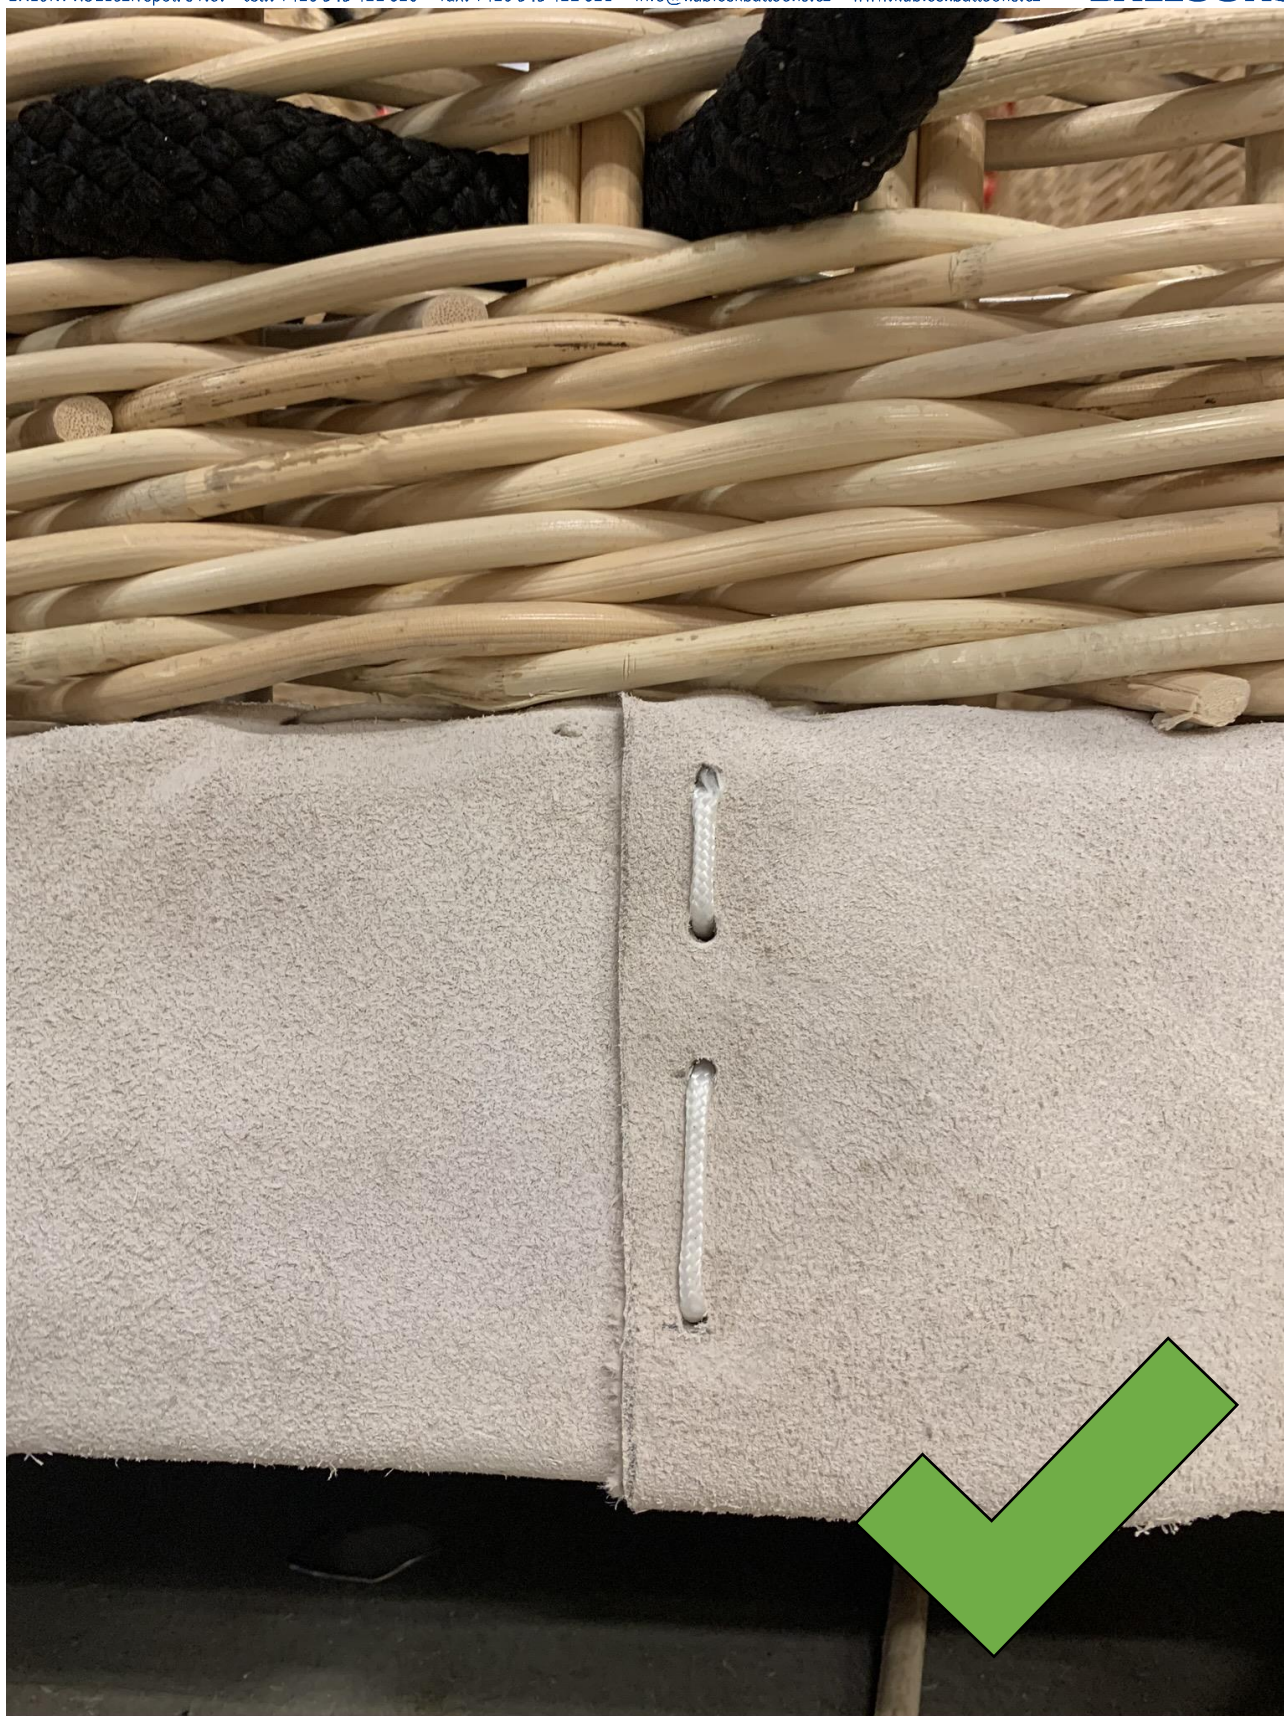
*Fig. 10: Connection of two rawhide leathers together*

With floor and floor covers assembled, next step is to attach rawhide leather (must be soaked in advance to be flexible), firstly to rattan canes by 3 mm polyester line. Please remember to leather shriveling (in all directions) during drying and use bigger pieces of leather. To avoid damage of leather by steel tubes of frame, is used MIRELON, which must be on outer side of tubular lower frame, under leather (please see Fig. 9). Next step is to bend leather around floor edge. After bending, leather is stapled to floor in two rows with offset, dimensions are shown of Fig. 9. Excess leather must be cut away. As reference for style of connection between leather pieces, please see Fig. 11, where is shown used basket and how is line tied in leather, however after connection and dry up of leather, holes must be in one line, as shown in Fig. 10.

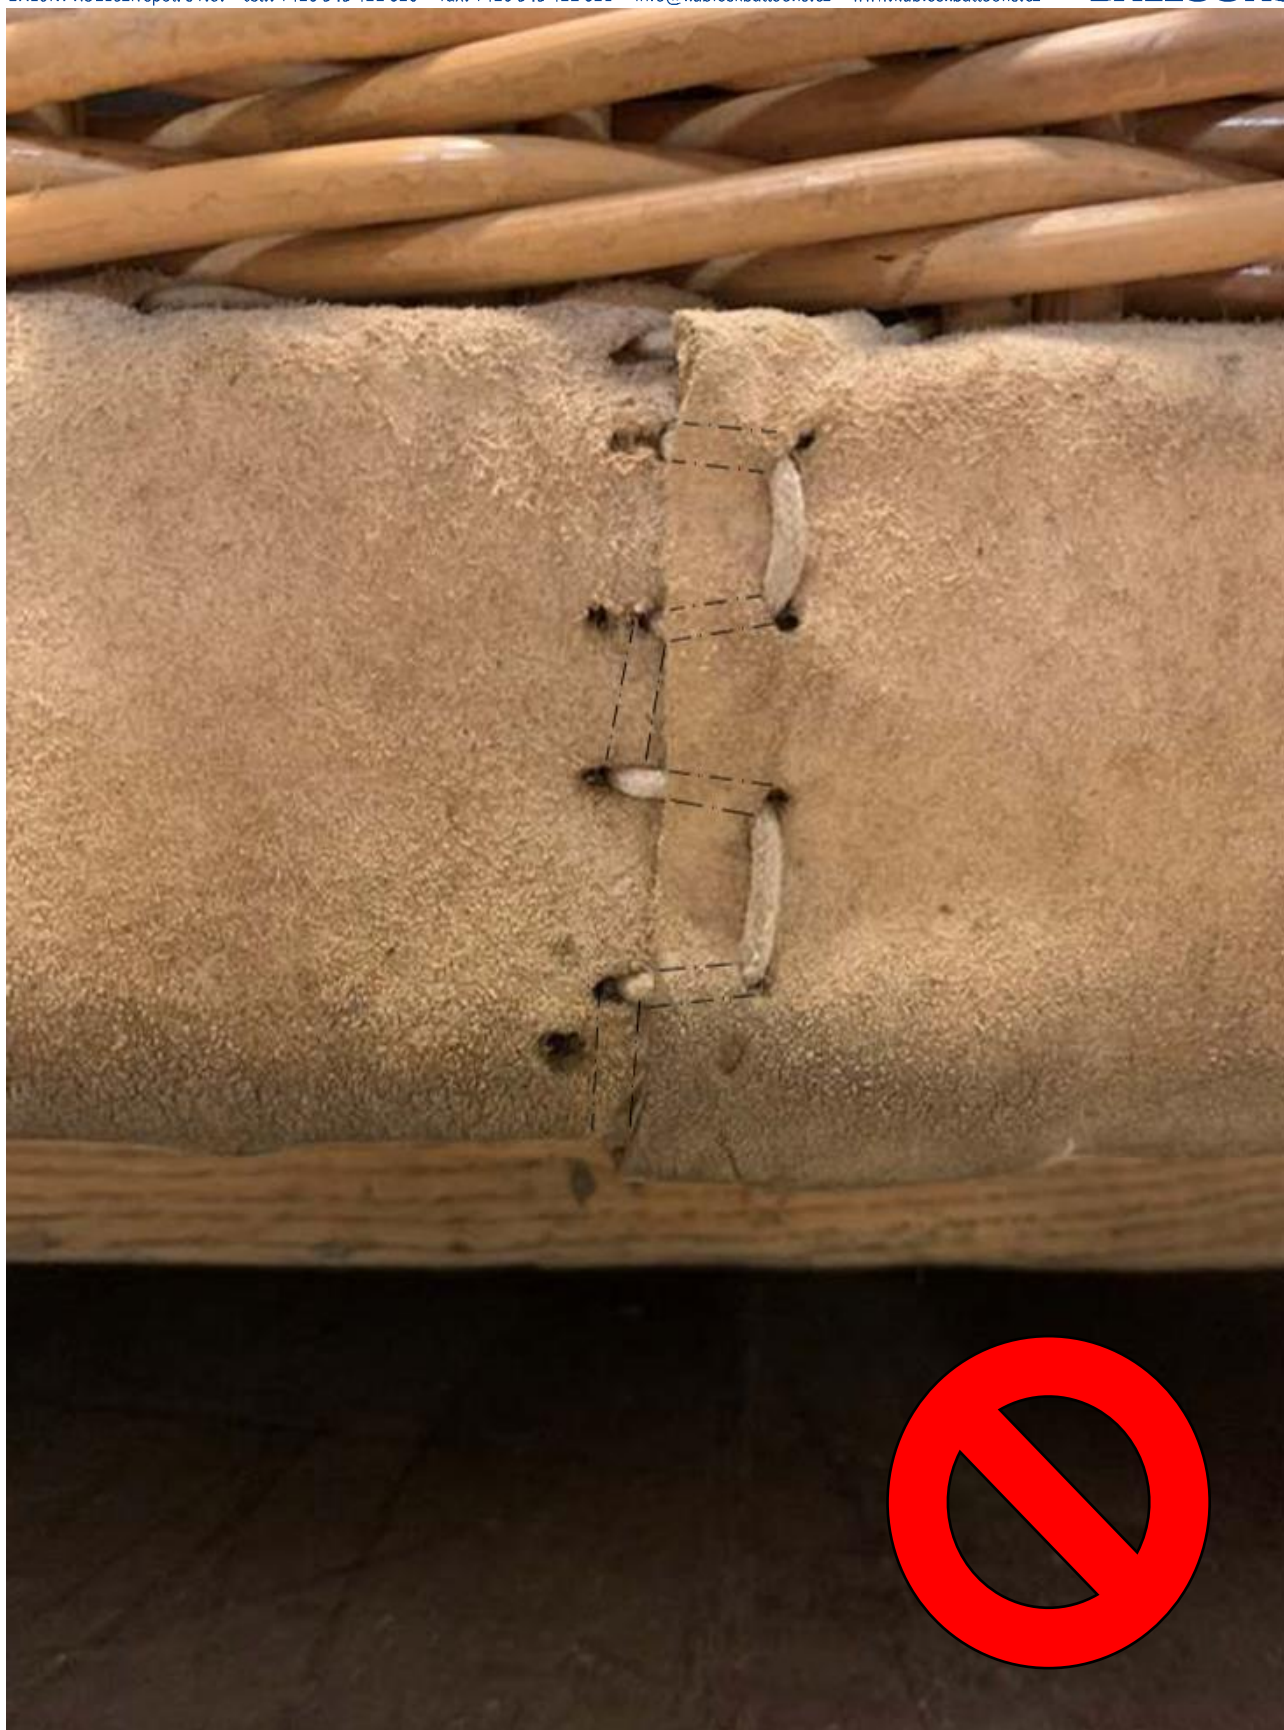
*Fig. 11: Connection of two rawhide leathers together (please note, that in picture is used basket and it only represents method of connection, however on new product are holes in both pieces at same line – see Fig. 10). This offset happens, when connected leathers are still wet, because during drying leather is shriveling.*

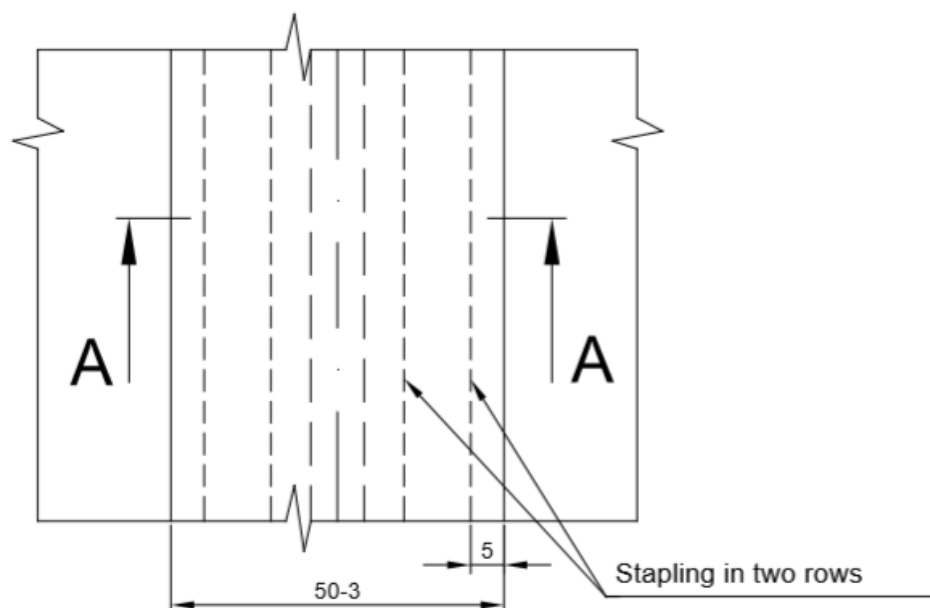
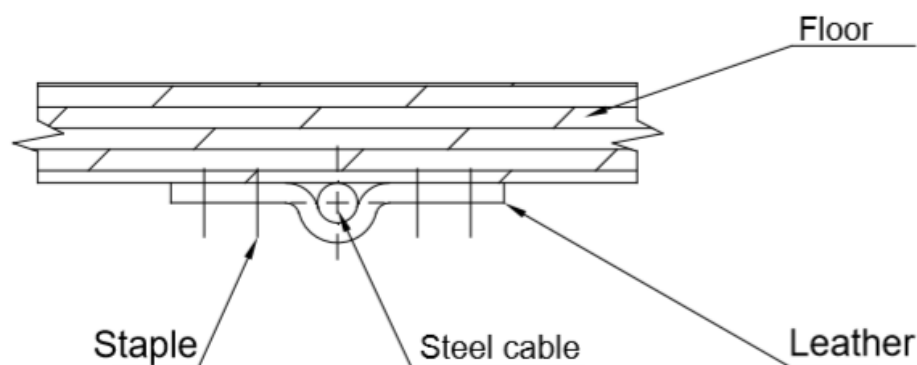
*Fig. 12: Stapling steel cable cover*

Steel cables must be covered by leather band, which is stapled to floor in two rows on each side (Fig. 12). After covering cables floor runners must be assembled according to Fig. 13 and 14.
