## SERVICE INSTRUCTION no. 2020/01

### Repair method of damaged K40Y basket corner

**With reference to:** Kubicek Balloons K40 Y basket, S/N 140

**Action:** Repair of damaged corner

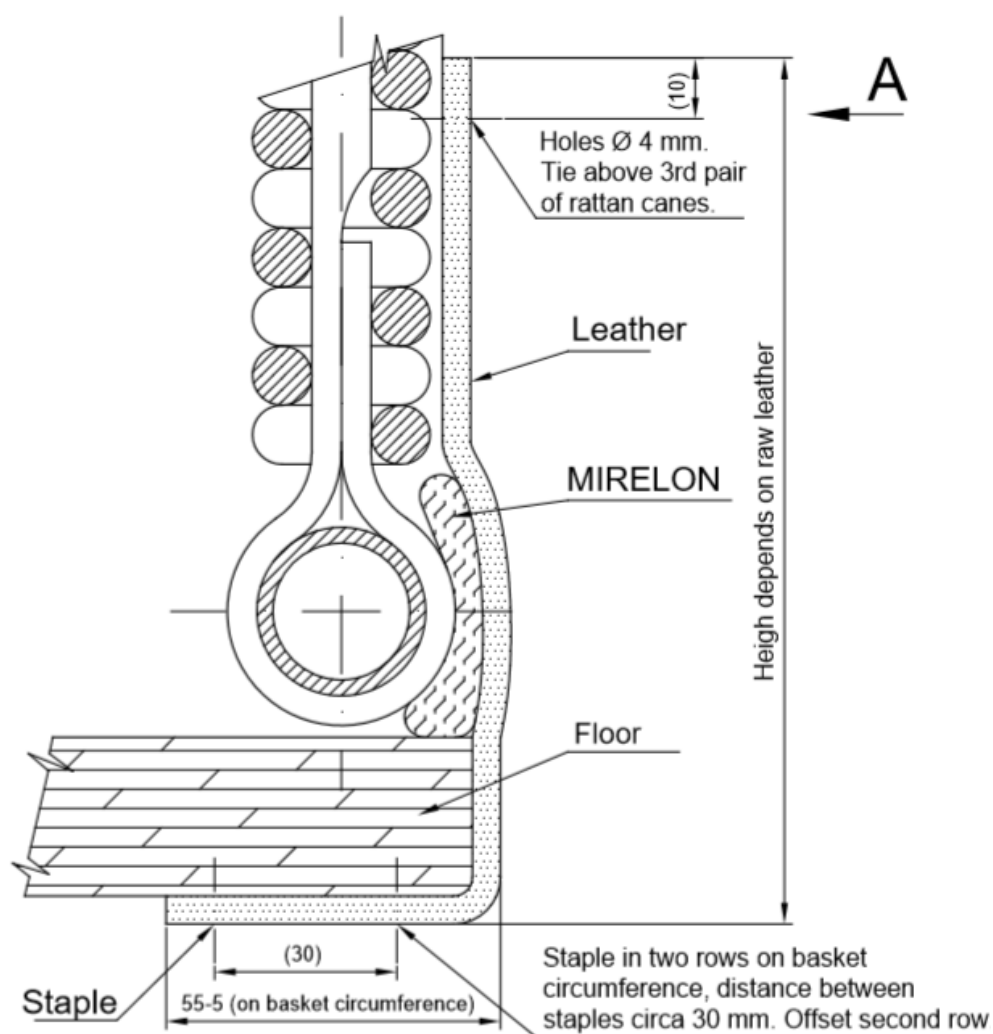
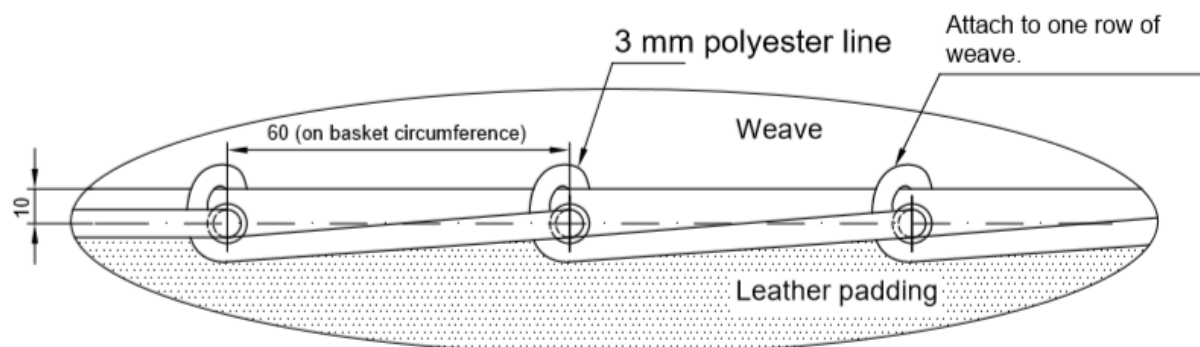
Fig. 9: Leather and MIRELON padding assembly

Detail of tie between lower leather padding and weave of basket.

With floor and floor covers assembled, next step is to attach rawhide leather (must be soaked in advance to be flexible), firstly to rattan canes by 3 mm polyester line. Please remember to leather shriveling (in all directions) during drying and use bigger pieces of leather. To avoid damage of leather by steel tubes of frame, is used MIRELON, which must be on outer side of tubular lower frame, under leather (please see Fig. 9). Next step is to bend leather around floor edge. After bending, leather is stapled to floor in two rows with offset, dimensions are shown of Fig. 9. Excess leather must be cut away. As reference for style of connection between leather pieces, please see Fig. 11, where is shown used basket and how is line tied in leather, however after connection and dry up of leather, holes must be in one line, as shown in Fig. 10.
