## SERVIS BULLETIN No. BB/51

1. WITH REFERENCE TO: All hot-air balloons Kubicek and Aerotechnik operated with Ignis 2-

2. REASON: Weld crack of suspension of Ignis 2-units burner

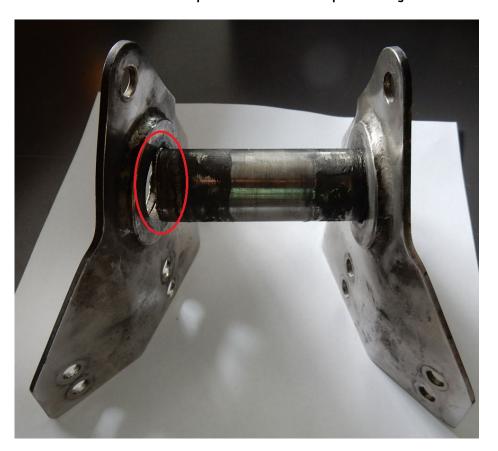
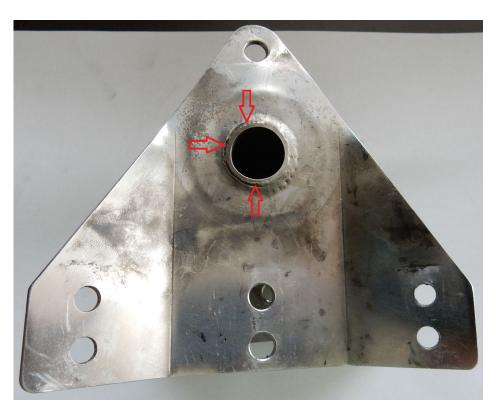
$\label{eq:enclosure 1} Enclosure \ 1 \\ \textbf{Example of a weld crack of suspension of Ignis 2-units burner}$

**10. ENCLOSURES:** 1. Example of a weld crack of suspension of Ignis 2-units burner

**3. REQUIRED ACTION:** Replacement of suspension of the burner units

8. PROCESS: Replace the burner suspension. Follow the instructions given in appropriate

Maintenance Manual.
